**To:** Elena Kamaeva  
**CC:** J. Baratuci  
**Subject:** Summary Performance Results - Truspacer Competitor Analysis  
**From:** D.L. Pruchenski **Date:** April 29, 2011

A sample of a competitive spacer system brand name “Truspacer”, product code 10#-39H-824, appears to be a product from Panjin Zhucheng Plastic Co. Ltd located in China. A preliminary analysis of the competitive spacer system is reported here including: product nomenclature & packaging comparison, component dimensional review /general compositional analysis using basic reverse engineered techniques (subassembly and bulk compound comparison through photo-documentation of stream materials and TGA screening analysis), and competitive product performance benchmarking.

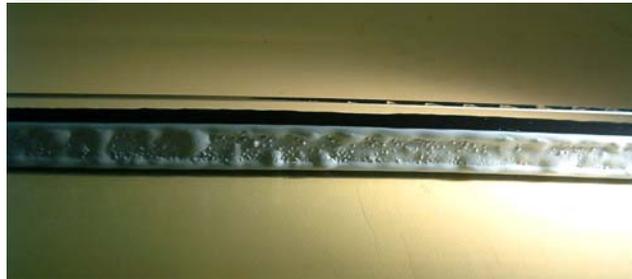
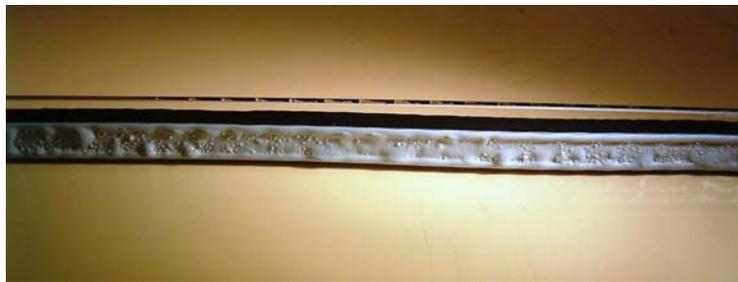
**Figure 3: Top Coat Anomalies**

All units in humidity and temperature cycling exhibited severe top coat anomalies after even this short exposure period. The top coat anomalies, Figure 3, were originally thought to be some sort of Argon blistering. However, a similar phenomena occurred in the QUV chamber, see Figure 4 after 1,283 hours. QUV regimen used is UV radiation exposure at 60C for 6 hours and then 40C without UV for 2 hours. Since the samples in the QUV were not exposed to Argon, it appears that this top coat blistering or degradation is heat related. The Truspacer product may not use UV or heat stabilizer additives.

It can be concluded that although the competitive Truspacer material (Panjin Zhucheng Plastic Co. Ltd.; Truspacer product code 10#-39H-824) visually appears to have replicated the Duraseal product in packaging, nomenclature, and design; competitive benchmark testing and analysis suggests that the overall performance (both thermal performance and seal durability/integrity) is inferior when compared to the Truseal Duraseal. Due to Truspacer's greater use of metallic alloys throughout the product, the Duraseal product should have a clear thermal performance advantage. The Truspacer product tested had an extremely slow dew point development. The seal durability in accelerated weathering performance was extremely poor with 4/6 high humidity units failing after just 2 weeks exposure and 6/6 units failing after 2 weeks in temperature cycling exposure. The performance in accelerated heat and UV exposure also suggests the stabilizer package is inadequate to protect the sight line top coat from degradation which would affect the aesthetics of the spacer and could eventually impact the seal integrity.

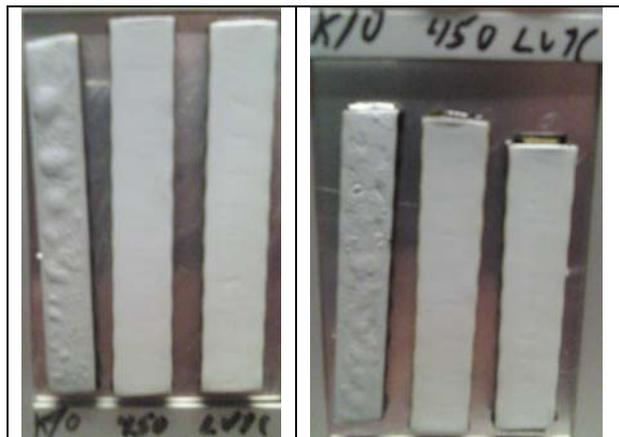
**Figure 4: QUV Exposure Samples - 1,283 exposure hours**

The sample on the left in each picture is Truspacer. The middle sample is standard Duraseal. The sample on the right is an experimental low volatility topcoat developed for future Dura products.
